IN THE MATTER OF THE
INVESTIGATION OF THE SOUTHWEST
GAS INCIDENT THAT OCCURRED AT
2710 W. BELL ROAD, PHOENIX,
ARIZONA, ON SEPTEMBER 28, 2007.

Staff Memorandum

RE: REPORT ON THE STATUS OF THE INVESTIGATION OF THE INCIDENT
OCCURRING AT 2710 W. BELL ROAD IN PHOENIX, ARIZONA ON SEPTEMBER
28, 2007.

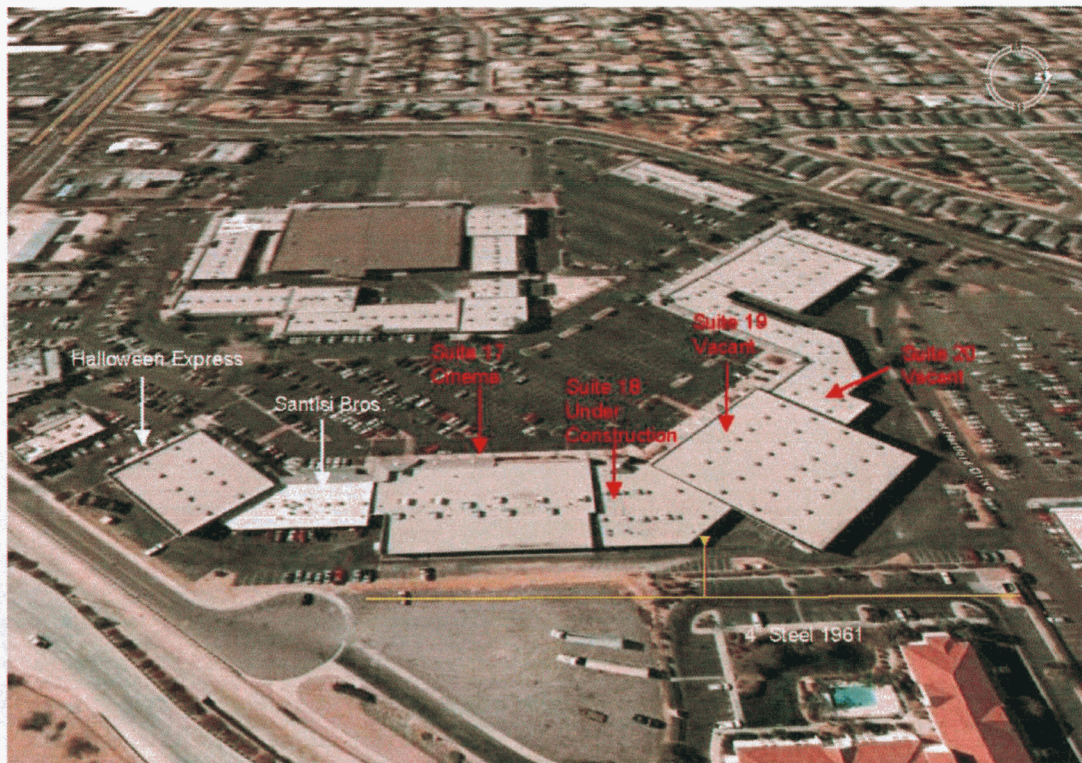
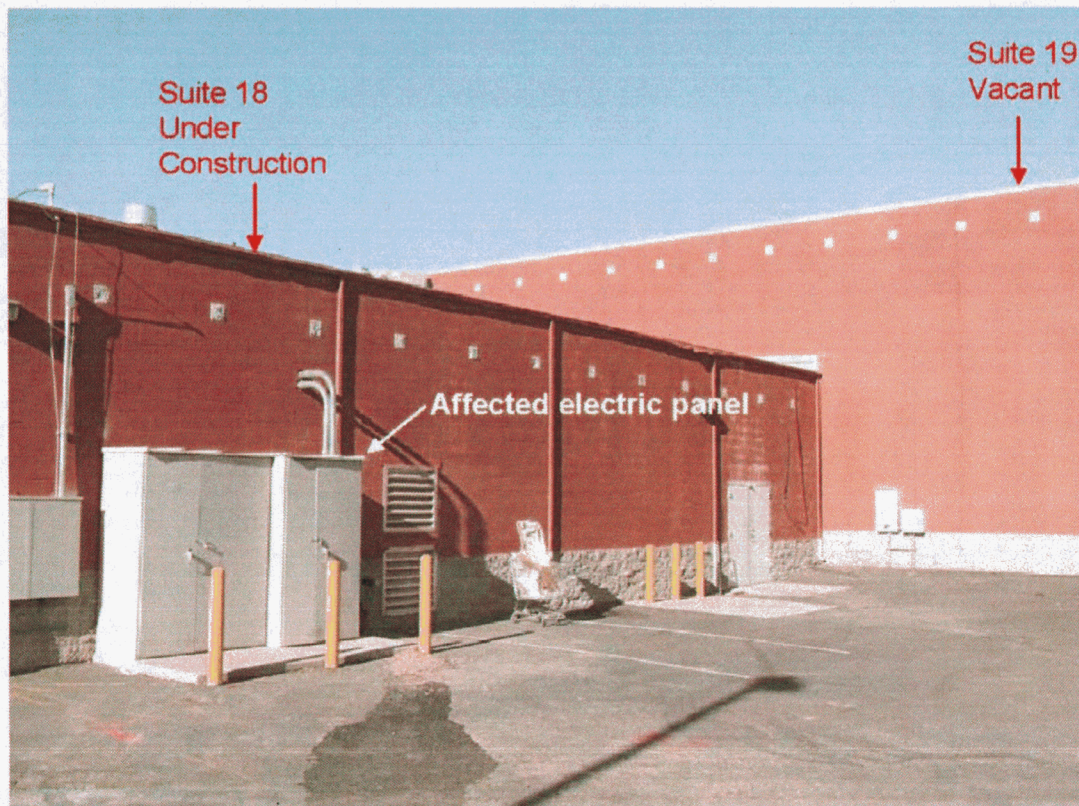
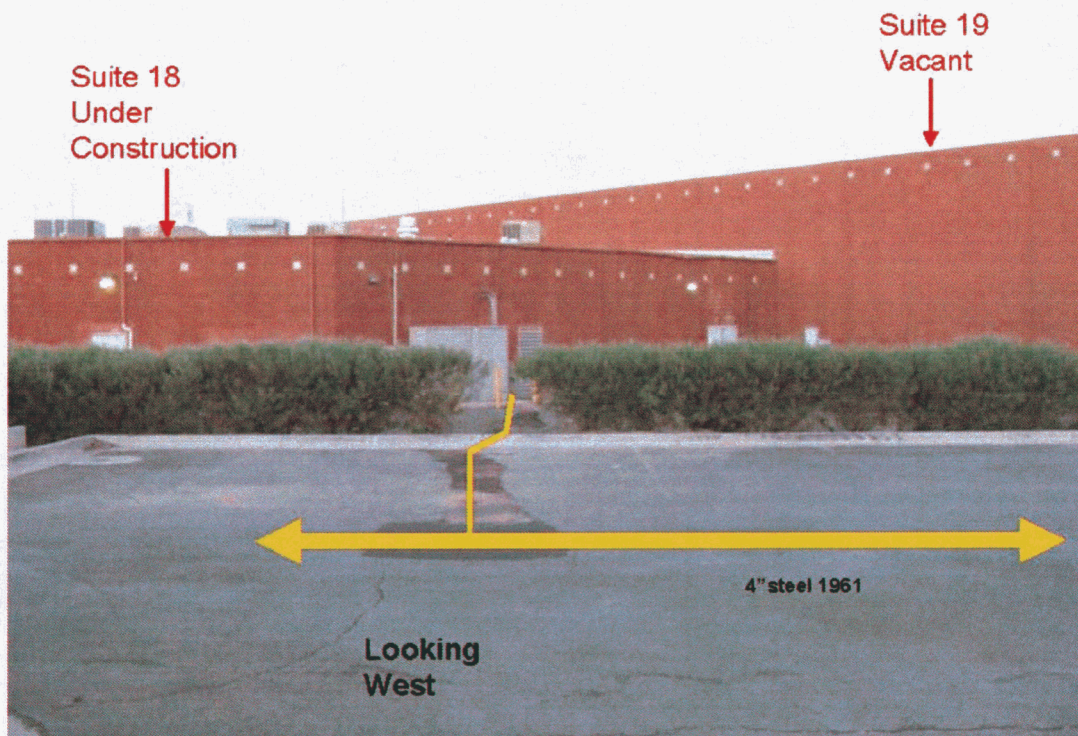
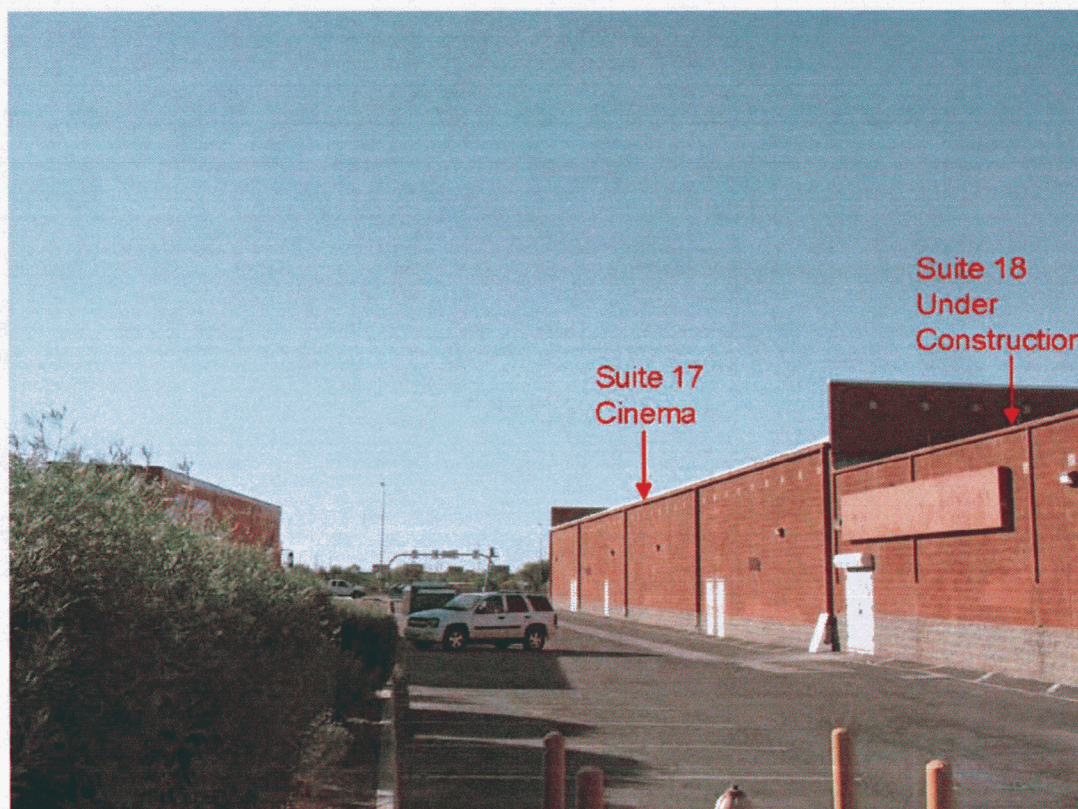
Attachment 1

1. On Friday, September 28, 2007, a Southwest Gas Company (Southwest) Dispatch employee received a call from the Phoenix Fire Department (PFD) regarding a fire at an outdoor retail mall at 2710 West Bell Road in Phoenix, Arizona. A Southwest Customer Service Technician established command upon his arrival at the property. An APS Troublemaker who arrived on scene prior to the arrival of Southwest's first responder personnel, informed the Southwest employee that a fire occurred in an electrical cabinet, that it had been extinguished, and that the PFD had already arrived and departed from the scene. The Southwest employee conducted an underground leak investigation. He found gas reads in the storm drain, in the conduit within the electrical cabinet, and at the foundations of suites 18 and 19 of the retail mall that exceeded 40% Lower Explosive Level (LEL). Based upon the amount and extent of exterior gas concentrations being found to be limited to suites 18 and 19, the measurement of 0% LEL gas concentrations in the rear entrance doorway to suite 18, and the absence of any smell of gas within that suite, the Southwest employee limited the extent of the areas that required evacuation to suites 18 and 19. The Southwest employee understood these two suites to be vacant based on statements made to him by facility management and observations made by him. There were no underground gas concentrations found at the foundation of the Cinema (suite 17). The nearest gas concentration found was behind suite 18, approximately 80 feet away from the Cinema. The Southwest employee did not request PFD and/or police involvement because he determined that their assistance was not required to gain access to, or to evacuate the affected vacant premises. (A map and photographs depicting this area are attached hereto as Attachment 1).

6. During this investigation, it was determined that gas had escaped from a leaking one inch plastic Polyethylene (PE) service line into an electrical conduit which terminated inside an electrical panel servicing the business located in suite 18 of the building located at 2710 West Bell Road, Phoenix. The business served by the electrical panel was a restaurant that was under renovation at the time of the incident.

8. The gas in the electrical conduit ignited, resulting in a small fire confined to the electrical conduit and electrical box. This fire was extinguished by the PFD who notified Southwest dispatch prior to leaving the scene of the fire.
